Solder Reflow Failures in Electronic Components during Manual Soldering

Alexander Teverovsky, Chris Greenwell,
Frederick Felt

Perot Systems/NASA GSFC, code 562,
Parts, Packaging, and Assembly Technologies Office
Alexander.A.Teverovsky.1@gsfc.nasa.gov

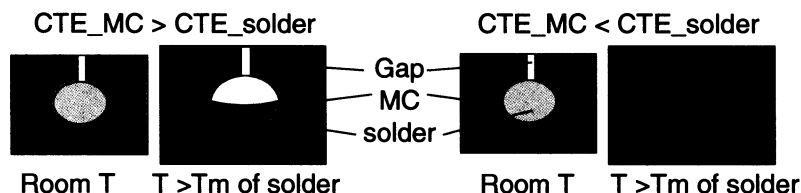
Molten solder does not wet glass/ceramic/plastic and should be pressed to flow in a gap by internal or external forces.

- Internal force: compressive stresses develop if expansion of solder > expansion of MC.

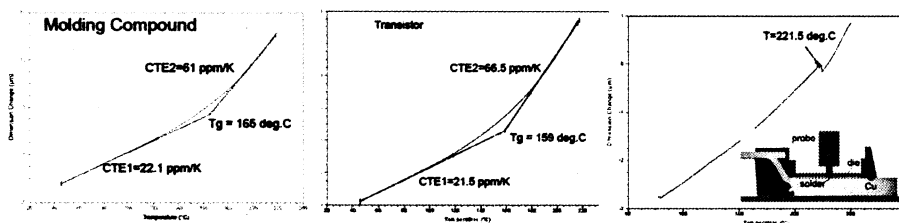
Average TMA characteristics

Deformation vs. temperature was measured on MC, transistors, and with a probe installed on a die (after decapsulation).

T _g , °C	CTE1, ppm/K	CTE2, ppm/K
MC	163	21.5	65
Package	165	23	70

Probe-on-a-die measurements confirmed that a high-temperature Sn/Ag solder with $T_m = 221^\circ\text{C}$ was used to mount die to heat spreader.

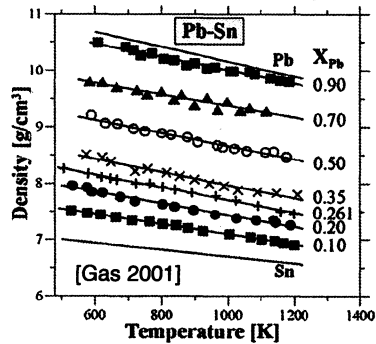
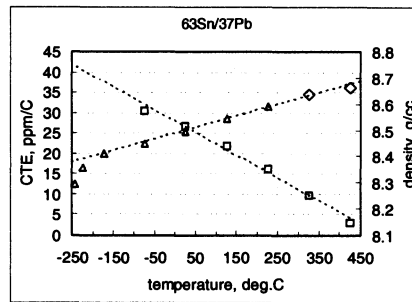
Available literature data on solder expansion were used for best-fit estimations of CTE and density at $-65 < T < 450$ °C.

Molten near-eutectic solder has
CTE = 34.5 ppm/K.

$$CTE = 0.0285 \times T + 24.93$$

$$\rho = 9 \times 10^{-4} \times T + 8.53$$

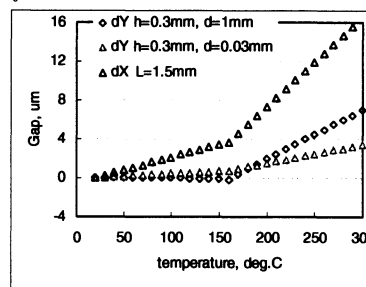
A size of MC/die gap, ΔY , was calculated assuming that at RT $\Delta Y=0$ and adhesion is negligible.

Compressive stresses ($\Delta Y < 0$) might occur at very thick layers of solder ($\delta \sim 1$ mm) only.

- ☐ Heating of the package uniformly creates enough room for solder expansion and no reflow failures should occur.
- ☐ Power FETs are designed for SMT for oven reflow soldering at $T \sim 250$ °C (up to 30 sec.), which exceeds $T_m = 221$ °C.
- ☐ Heating to melting temperature is a necessary but not a sufficient condition for reflow failures.
